COAST GUARD RESEARCH AND DEVELOPMENT CENTER GROTON CT
TRANSITORY FIRE RESISTANCE OF TANKER LIFEBOATS.(U)
FEB 80 D E BEENE
CGR/DC-27/79

1. Report No. 19 D-19-80	2. Government Accession No. AD-A084257	3. Recipient's Catalog No.	
4. Title and Subtitle U Transitory Fire Resistance of Tanker Lifeboats		5. Report Date 12 February 1980	6. Performing Organization Code

7. Author(s) 10 David E. Beene, Jr.		8. Performing Organization Report No. R&DC 27/79	
9. Performing Organization Name and Address United States Coast Guard Research and Development Center Avery Point Groton, Connecticut 06340		10. Work Unit No. (TRAIS)	11. Contract or Grant No. 72132

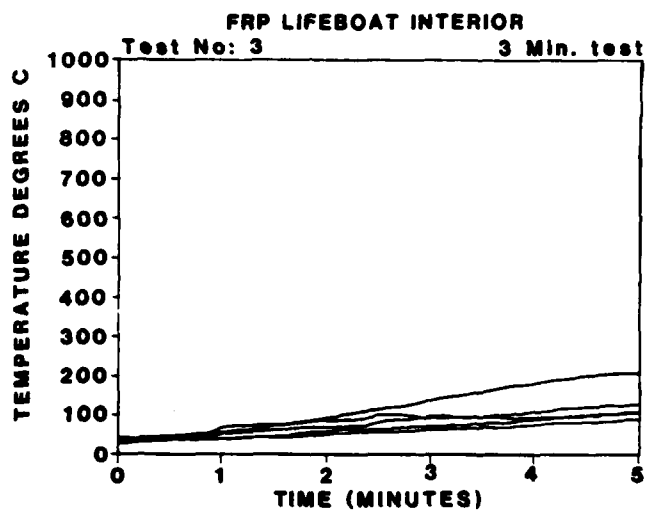
Figure 9

The FRP lifeboats charred in the short-term fires but were not seriously damaged (Figure 8) even though flame temperatures reached 1688°F (920°C). The charred hull was a poor conductor of heat as evidenced by the extreme heat differential between its interior and exterior surfaces (Figure 9). The fiberglass hull varied in thickness from 1.0 inch (2.54 cm) at the keel to 0.25 inch (0.64 cm) at the gunwale. It was constructed of four or more plies of woven roving fiberglass cloth with a mat of chopped fiberglass

Temperature Histories of a FRP Lifeboat in a Short-Term Fire
